# U.S. Army Center for Health Promotion and Preventive Medicine

## A SURVEY OF PARACHUTE ANKLE BRACE BREAKAGES

USACHPPM REPORT NO. 12-MA01Q2A-08

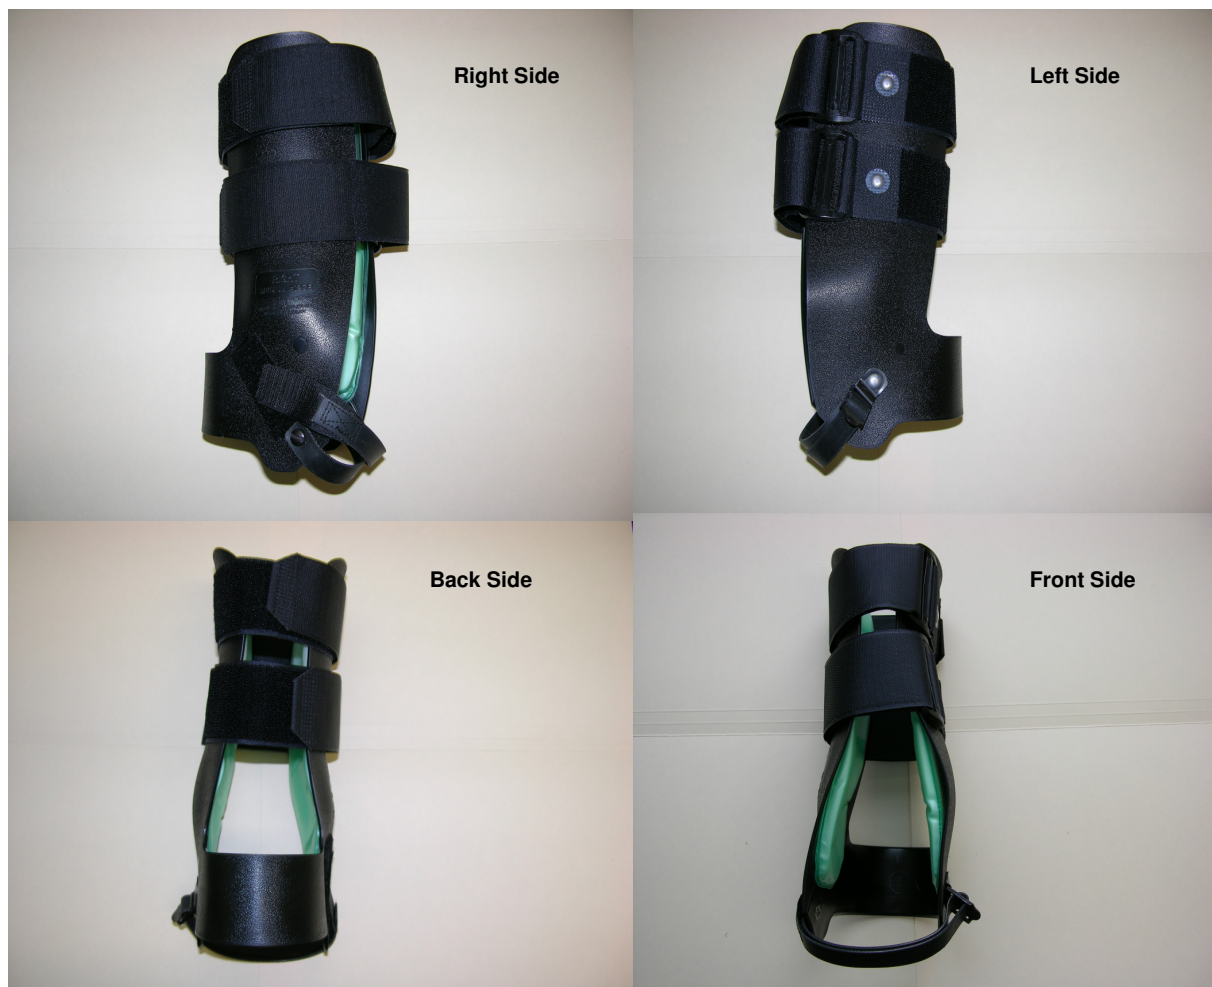
**Figure 1. First-Generation Parachute Ankle Brace**

**c. PAB Generations.** There have been three generations of the PAB produced by Aircast® Corporation and DJ Ortho®. The first, second, and third generation are shown in Figures 1, 2, and 3, respectively. The braces are similar with some small changes. The first generation brace had air sacks that padded the ankle and lower leg area. In the second generation PAB, these air sacks were replaced with closed cell foam. In the third generation PAB, the plastic composition was changed and a screw replace the rivet on the buckle side of the heel strap so the heel strap could be more easily replaced. During the PAB study of injuries from April 2005 to December 2006 (12), the second generation brace was used. After completion of the injury study, third generation braces were purchased for the USAAS and these were gradually phased into training.

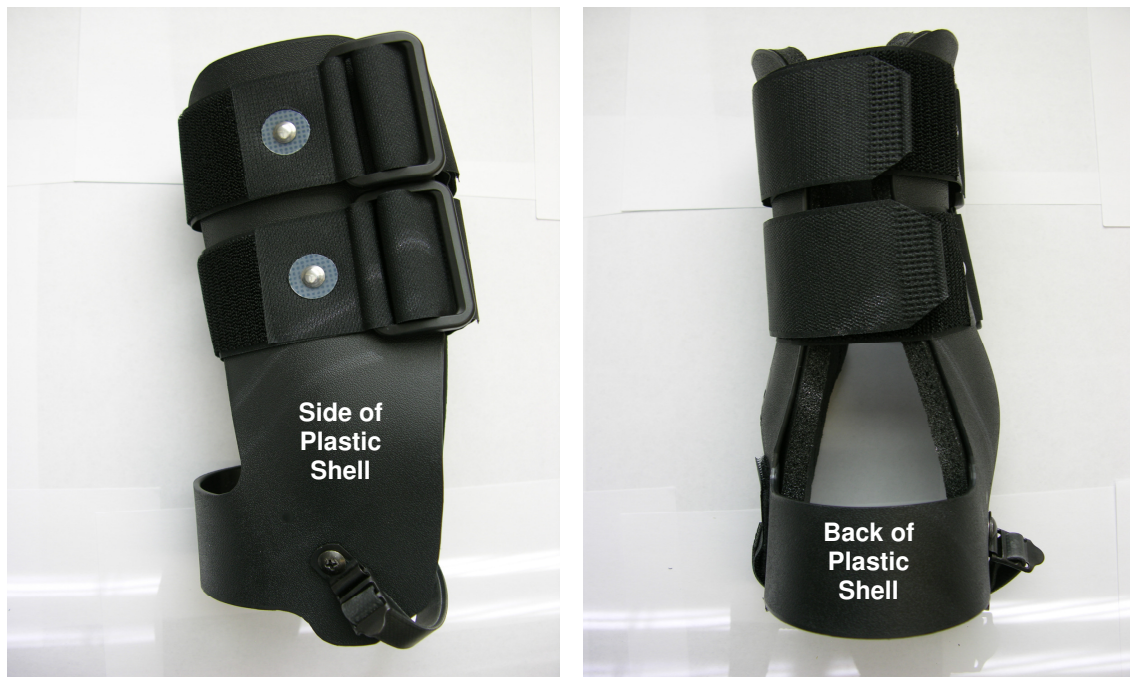
**Figure 4. Parachute Ankle Brace Plastic Shell Components**

(2) Four batches of braces were returned to the USACHPPM between June 2005 and September 2007. Returned braces were inventoried by the USACHPPM and a categorization scheme was developed based on the breakages observed. Breakages could have involved three major areas: 1) the plastic shell, 2) the ankle strap, or 3) the heel strap. The plastic shell could be broken at the side or back (Figure 4). There were two ankle straps (top and bottom) and breakages could involve 1) a strap torn near the rivet, 2) a strap torn at Velcro hooks, 3) a strap torn in middle, and/or 4) a broken buckle (Figure 5). Breakages at the heel strap could involve 1) a tear near the middle, 2) a tear in Velcro portion of the strap, 3) a broken heel strap rivet or screw on the buckle end, 4) a broken heel strap rivet or screw on the Velcro end, and/or 4) a buckle severely bent and not serviceable (Figure 6).

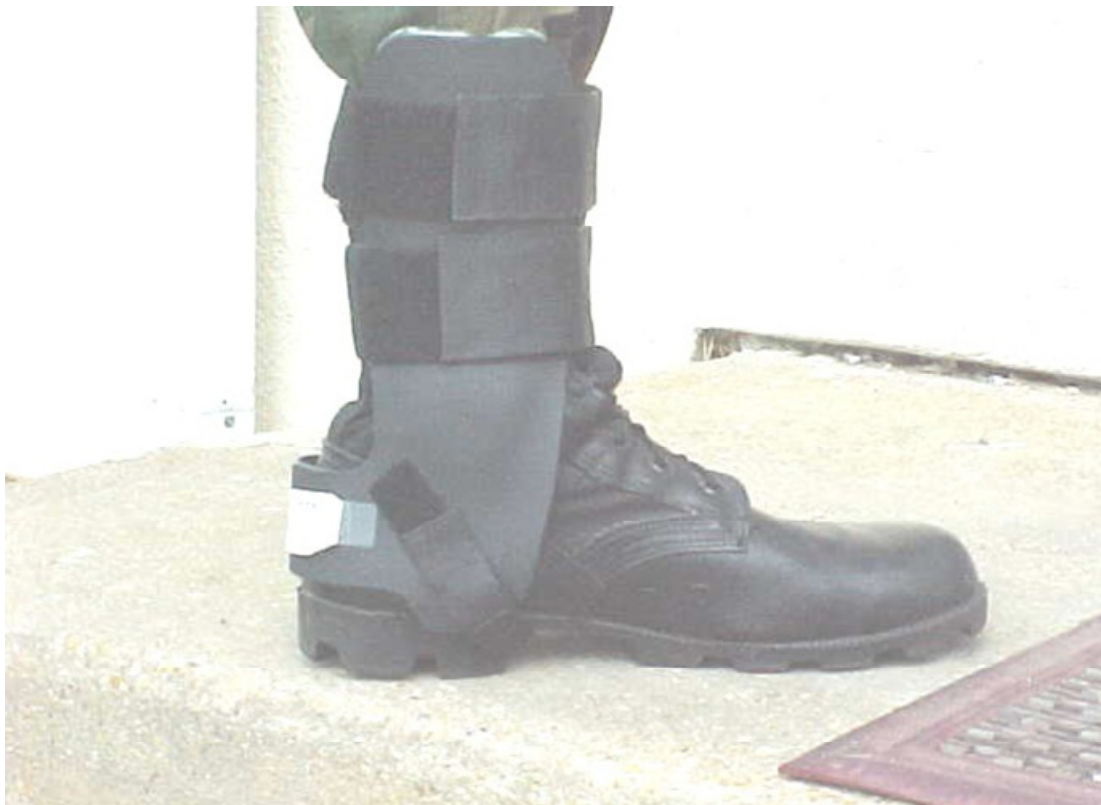
**Figure 7. Parachute Ankle Brace on the Older Black Combat Boot**

b. The reason for heel strap breakages is most likely the change in the military boot. The heel strap was originally designed for the older black combat boot as shown in Figure 7. This boot had a heel and the heel strap fit under the instep of the boot in front of the heel. This area secured the PAB to the boot, preventing backward slippage, and the heel strap was located where it would experience minimal contact with the ground. The first “new” boot was the desert boot with a heel (Figure 8) so the heel strap was still useful. However, about July 2005 a newer desert boot was issued in Army Basic Combat Training (Figure 9) and this new boot had a minimal heel area. Soldiers arriving at the USAAS from BCT had this new boot. When the PAB was placed on this new boot, the heel strap could slip over the curved part of the heel causing the plastic shell to move backward during walking. When this happened the heel strap was also directly under the heel and subject to abrasion from concrete in the harness shed, asphalt on the loading ramp, and dirt on the drop zone. The heel strap life span was considerably reduced.

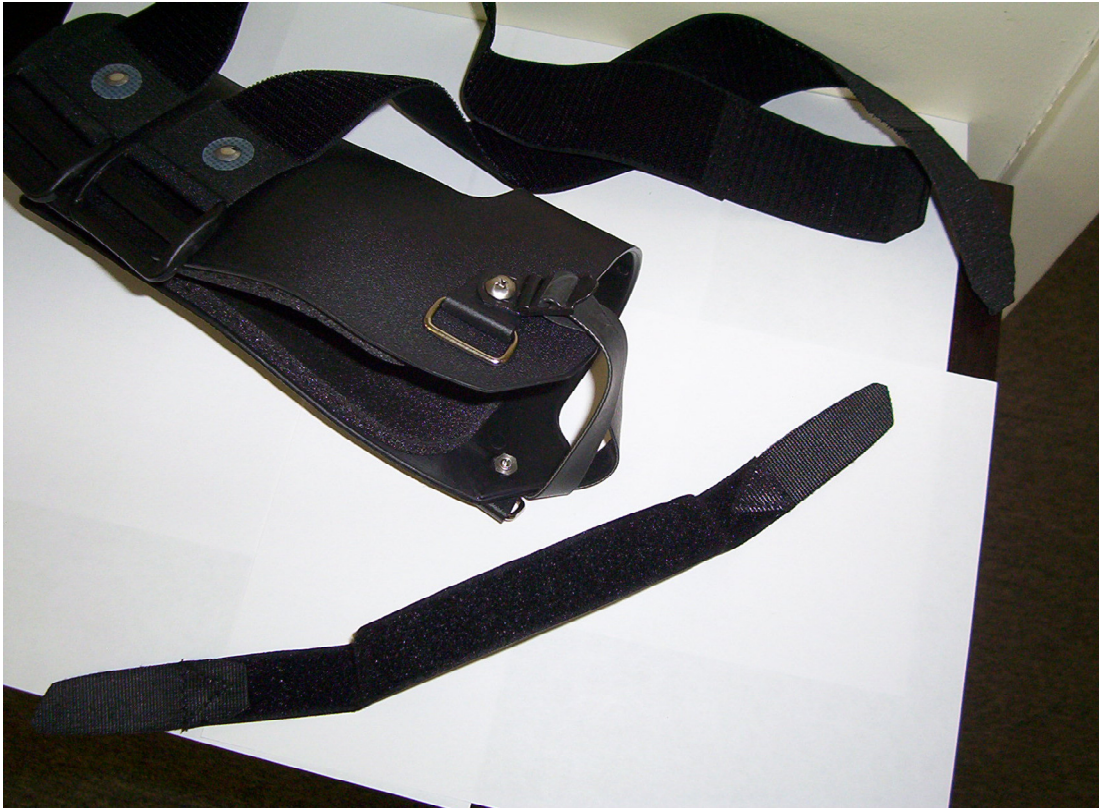
**Figure 10. Modified PAB for New Army Boot with Minimal Heel**

c. DJ Ortho<sup>®</sup> in consultation with the USAAS developed a design that adds a stabilizing strap over the dorsum of the foot. Figure 10 shows a first prototype. A buckle loop is attached to the heel strap screws on both sides of the brace. A Velcro strap is inserted into the loop and secured across the top (dorsum) of the foot to better hold the brace in place. This should improve the stability of the PAB by preventing it from slipping off the boot. The heel strap should no longer slip back from the instep and will be afforded some protection as it should no be stepped on.
